Centennial WTP
Pelham, MA

**Centennial Water
Treatment Plant
Upgrade Evaluation
and Preliminary Design**

**Town of Amherst
Amherst, MA**

November 2010

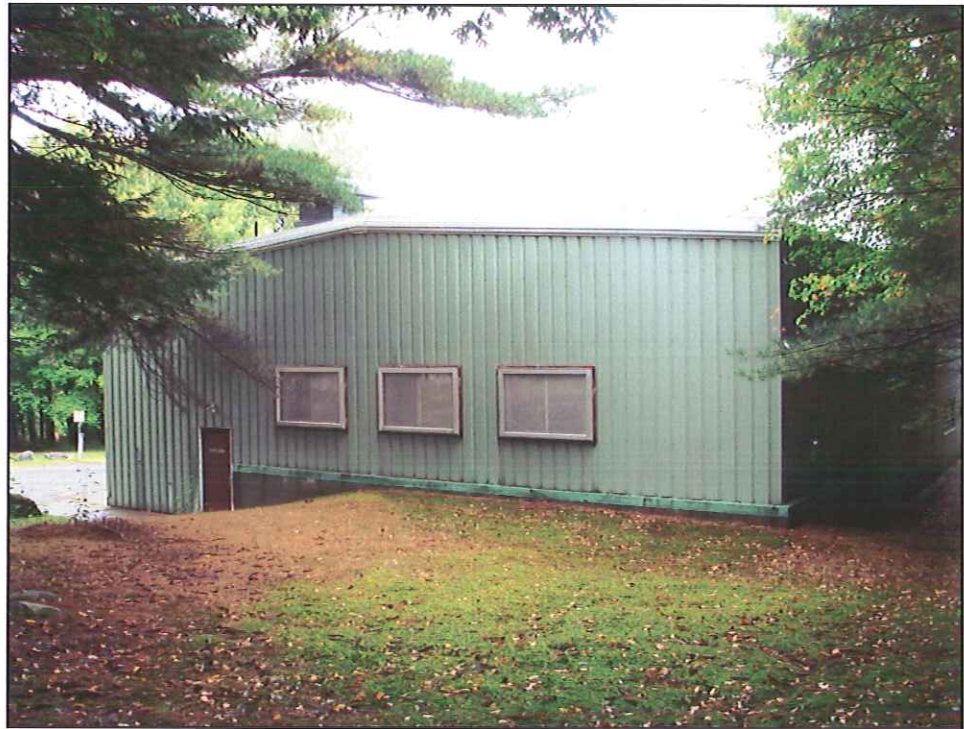
Photo 1-1: Centennial Water Treatment Plant

The Centennial Water Treatment Plant (Centennial WTP) located off of Amherst Road in Pelham, was constructed in 1981, and treats water from the Hill and Hawley Reservoirs (WTP is shown in Photo 1-1). The plant is one of two surface water treatment plants that supply water to Amherst. Tighe & Bond assessed the condition of the plant and evaluated alternatives for rehabilitating the plant building and equipment.

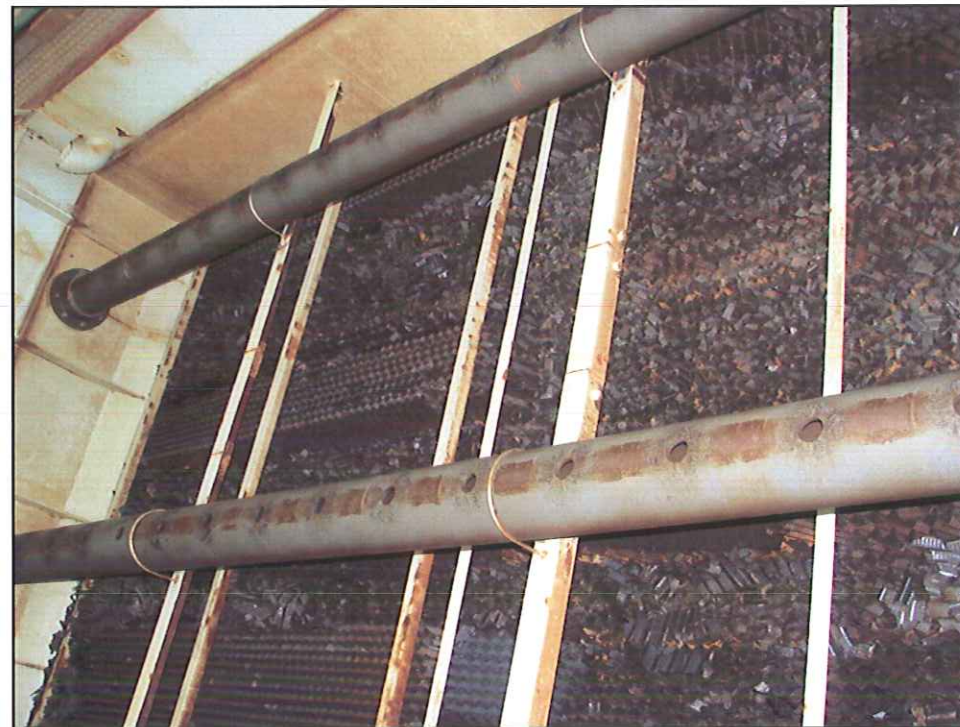
Photo 4-2: Tube Settlers in Treatment Unit No. 2

The existing tube settlers are in poor condition, and are severely degraded, particularly in Treatment Unit No. 2 (Photo 4-2). The manufacturer recommends replacement of the existing tube settlers with 24-inch high PVC tube settlers that would be supported by the existing tube settler support rack.

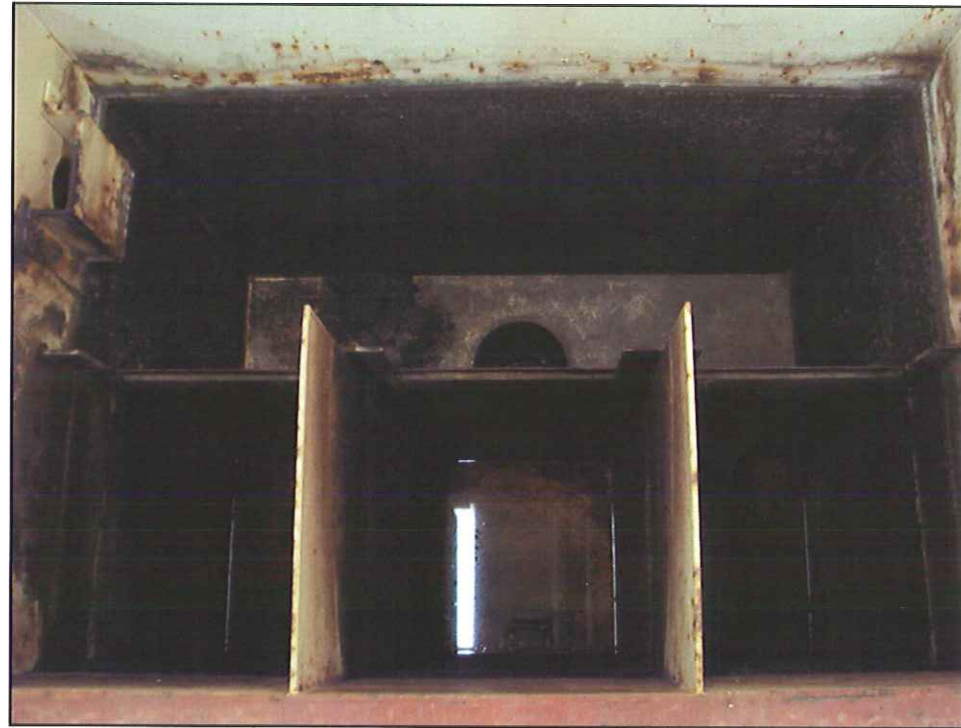
Photo 4-4: Existing Splitter Box Inflow Design

The flow splitter box (Photo 4-4 and 4-5) is located at the head of the filter units and splits the influent flow in thirds, in order to provide even flow through each filter. However, the Town of Amherst has indicated that the splitter box does not provide uniform flow to the filters and would like to make improvements to the system.

The current splitter box design allows water to enter a chamber. At the top of the chamber, the water is split into three flows via divider panels. Flow is directed over three weirs to the individual filter units. If the water surface is level and the weirs are at the same elevation, the system will deliver equal flow to each filter. The water enters the chamber in the center, aligned with the middle splitter box. This alignment appears to cause the water to boil slightly in the center, resulting in a slightly higher water level at the center weir resulting in more flow to the center Roberts unit.

To improve the uniformity of the flow to the filters, it is recommended that a flow distribution header be installed in the splitter box. The flow distribution header will consist of a PVC pipe with several evenly spaced outlets that will equalize the flow between the three filter units.

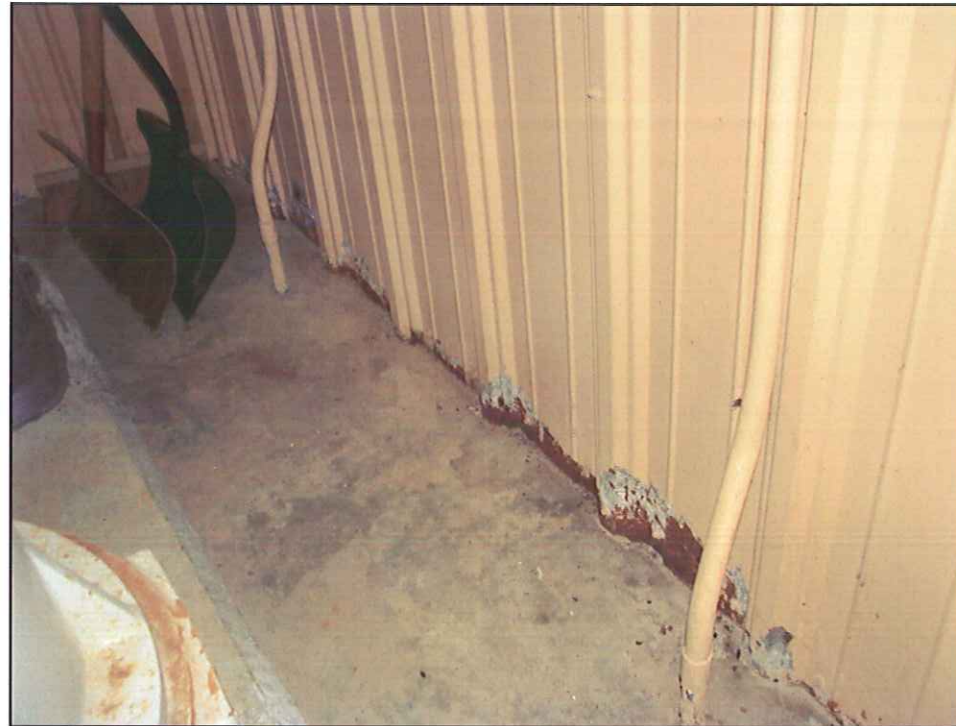
Photo 4-7: Rust on Interior Wall

The interior wall panels are showing signs of rust in several areas along the floor (Photo 4-7). Rather than replace the entire panels, which would require removal and reattachment of all the equipment located on the walls, we recommend saw cutting and removing the bottom 18 inches from the interior wall panels and installing an 8 inch wide by 16 inch high concrete curb below the wall. Installing a curb will prevent future rusting of the walls and provide a permanent solution to the problem.

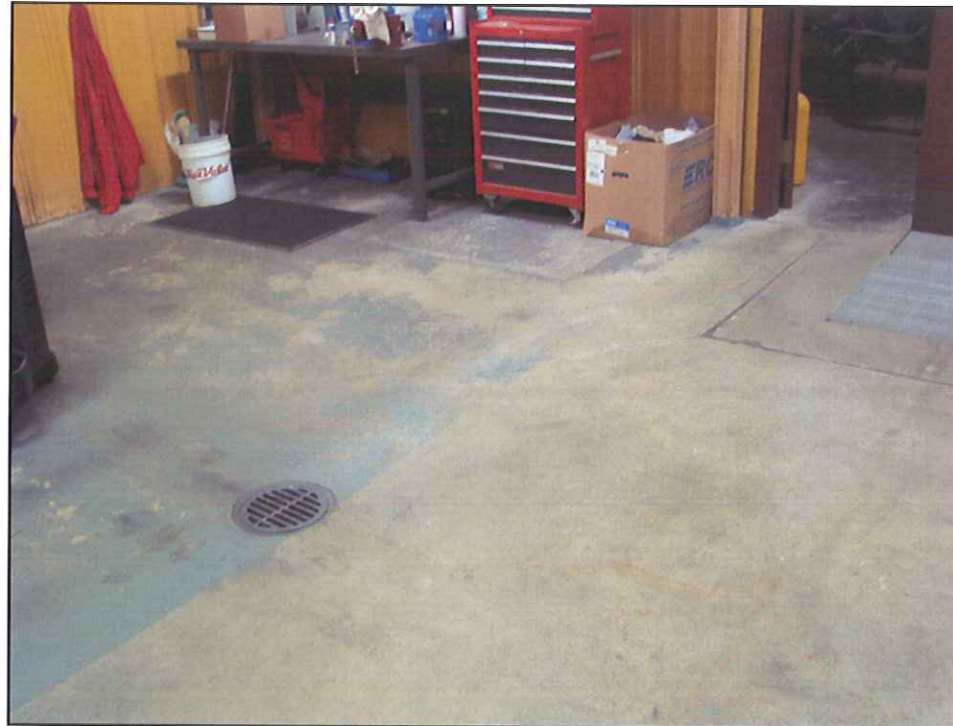
Photo 4-8: Deteriorated Paint on Workroom Floor

The existing paint is deteriorated (Photo 4-8). Painting the workroom floor is recommended.

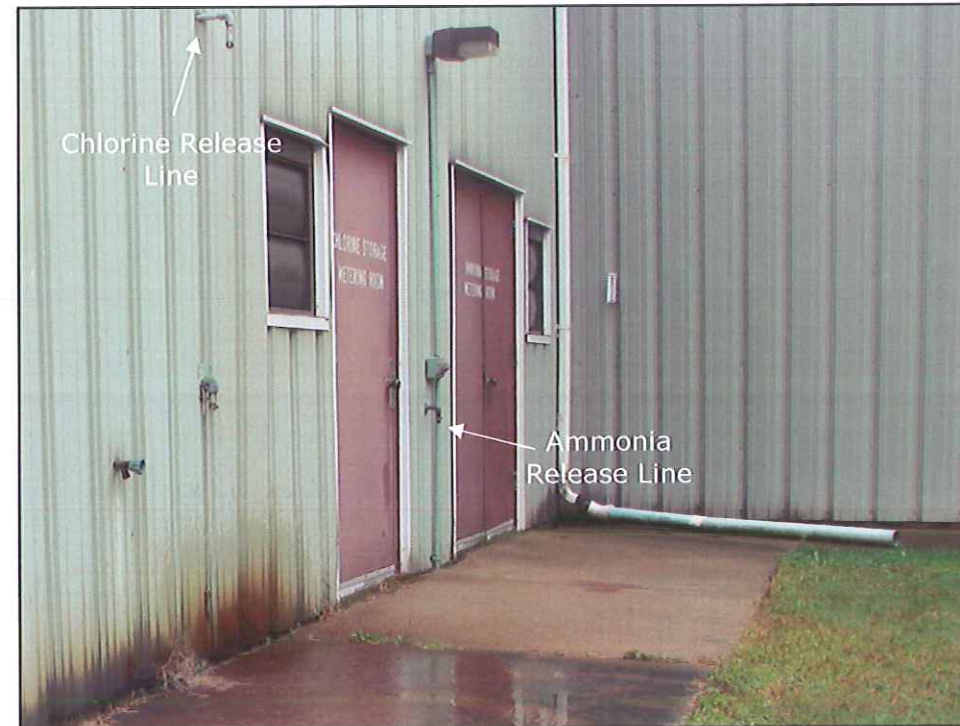
Photo 4-9: Exterior of Chlorinator and Ammonia Rooms

- The chlorine and ammonia pressure relief lines are currently routed through the exterior wall and discharge near the doors, creating a hazard for anyone trying to evacuate or approach the rooms in the case of a leak (see Photo 4-9). In order to provide a safe escape route, the release lines should be rerouted to the other side of the building, away from any air intakes.

- Install bright signal lights outside of each room to alert a visitor to chlorine and ammonia releases, in order to ensure that people at the site are aware of any existing hazards. The signal lights should activate when levels exceed OSHA permissible exposure limits, as follows:

- In addition to the identity of the chemical, hazard information should be posted on the doors to alert emergency responders in accordance with the requirements of NFPA 704M, as follows (H:Health (blue), F:Fire (red), R:Reactivity (yellow)):

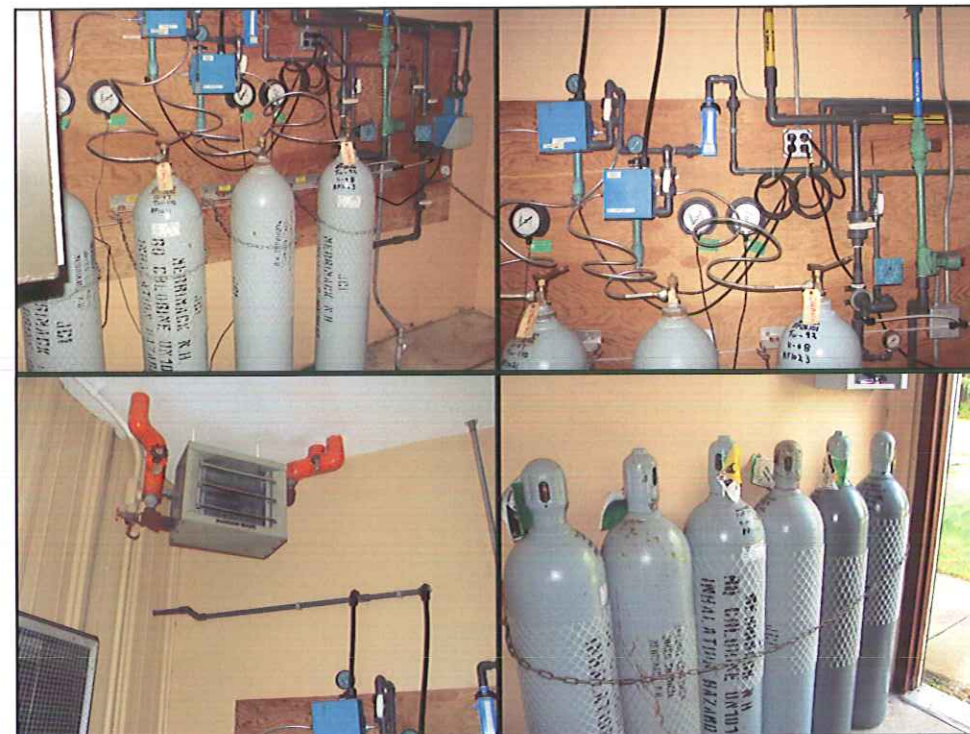
Photo 4-10: Chlorinator Room

- Upgrade the gas feed system to a vacuum system. A vacuum system would eliminate the sections of stainless steel tubing that currently operate under pressure and are prone to failure/leaks by installing the regulator directly onto the gas cylinder. The existing systems are depicted in Photo 4-10 and Photo 4-11. Vendor information is available in Appendix D.

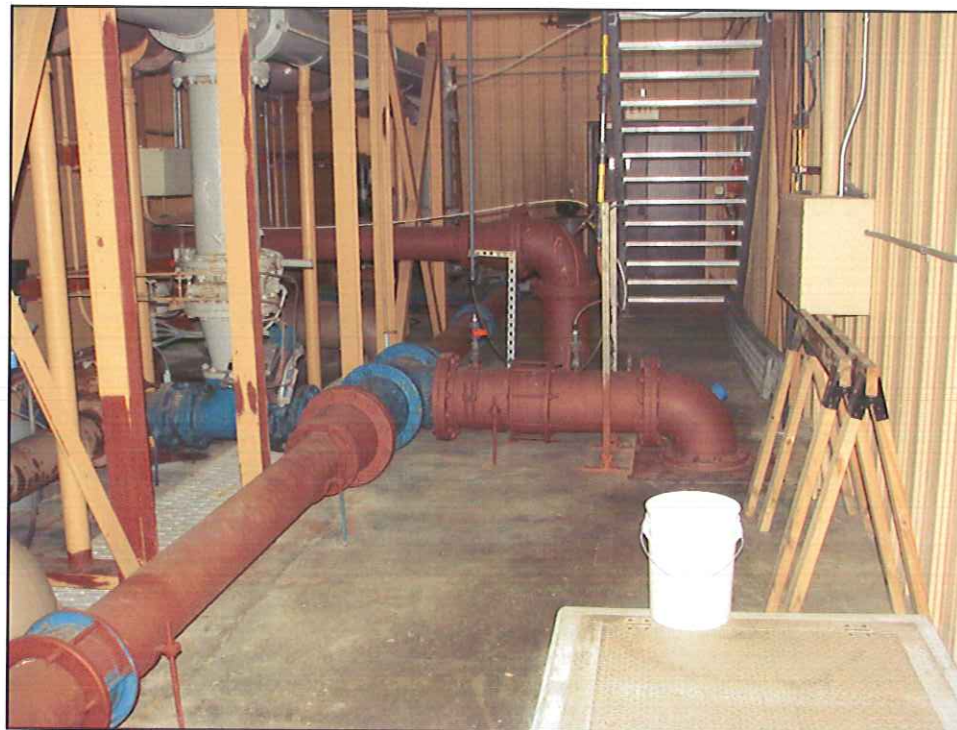
Photo 4-14: Location of UV Reactor modifications

The proposed UV system will require modification of the filter effluent piping between the filters and the chlorine contact chamber (Photo 4-14) in order to combine the flow from the three filter units and provide an adequate length of straight pipe upstream of the UV unit. A UV system bypass will also be provided. The layout of the proposed system is depicted in Figure 4-6. Vendor information is available in Appendix E.

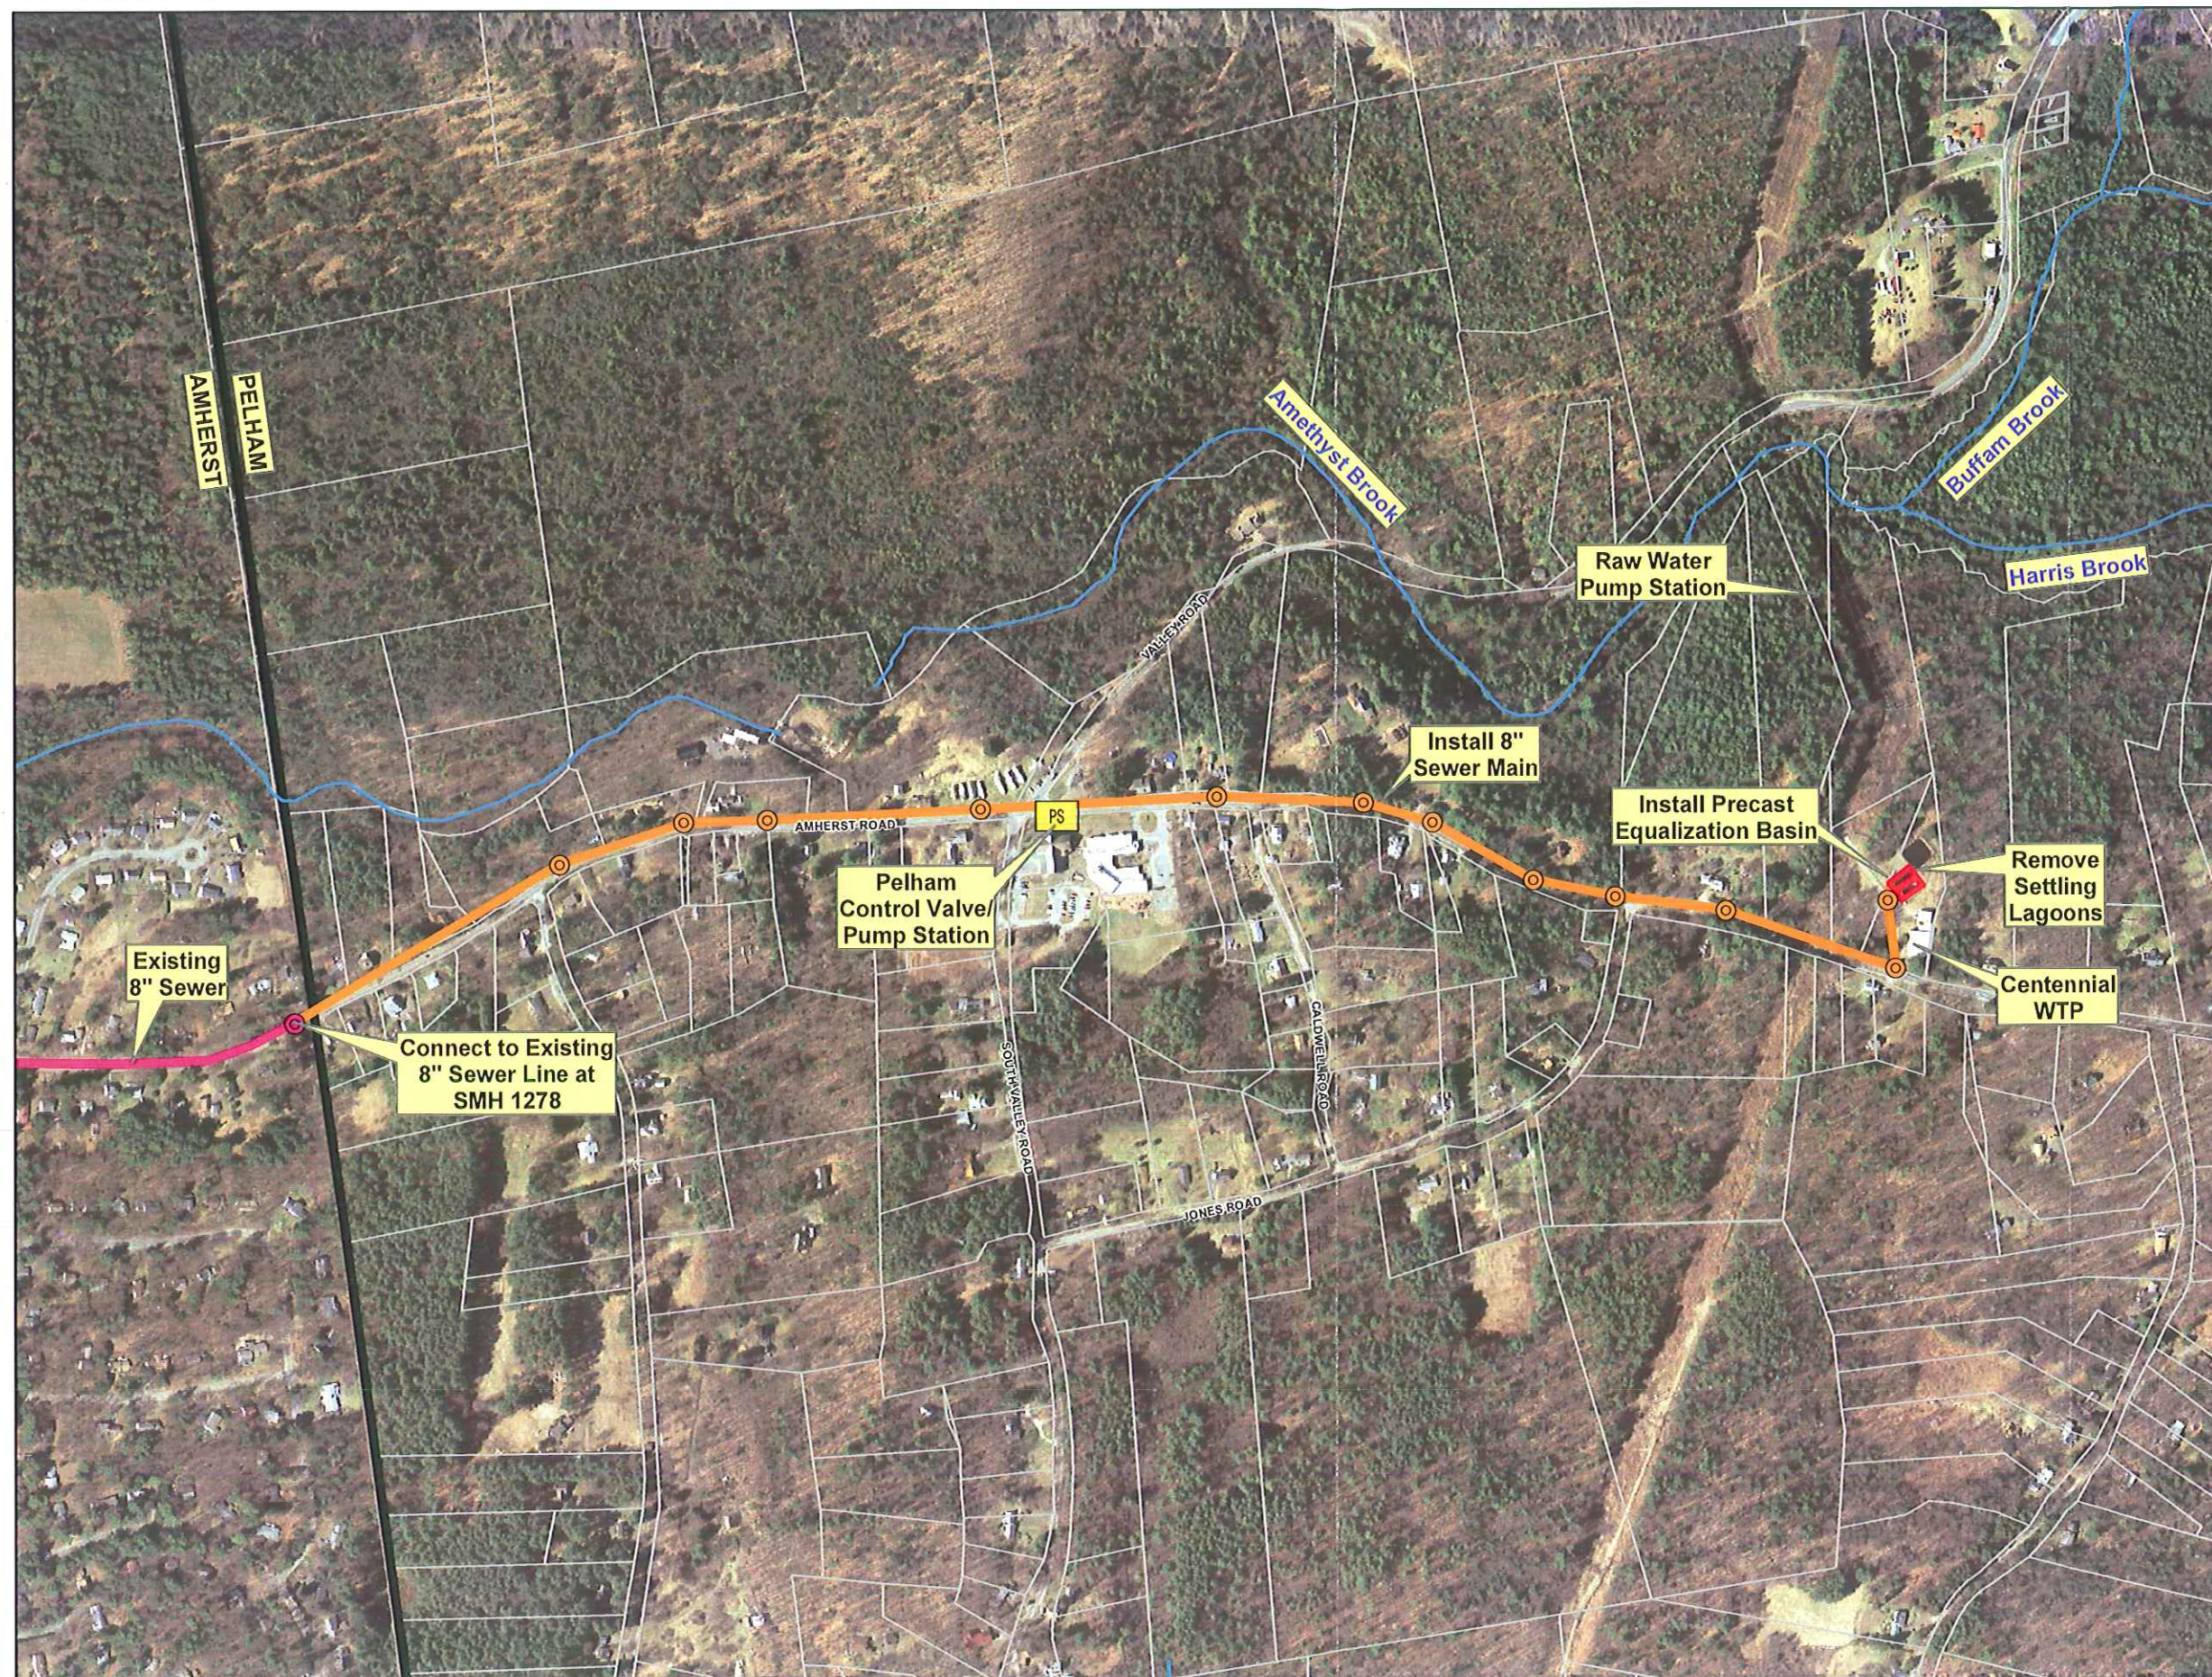
Figure 1-1
Centennial Water Treatment Plant
Existing Process Schematic

A flow diagram of the plant is presented in Figure 1-1, and a site plan is presented in Figure 1-2. The primary process equipment consists of three package filtration units manufactured by Roberts Filter Group. Each unit consists of two flocculation basins, a sedimentation basin with inclined tube settlers, and a dual media anthracite over silica sand filter, installed within a 46 foot long by 10 foot wide steel tank, with the treatment
